Chapter 4

Lessons Learned from the Recent Natural Disasters in Indonesia

Sri Prabandiyani Retno Wardani and Agus Setyo Muntohar

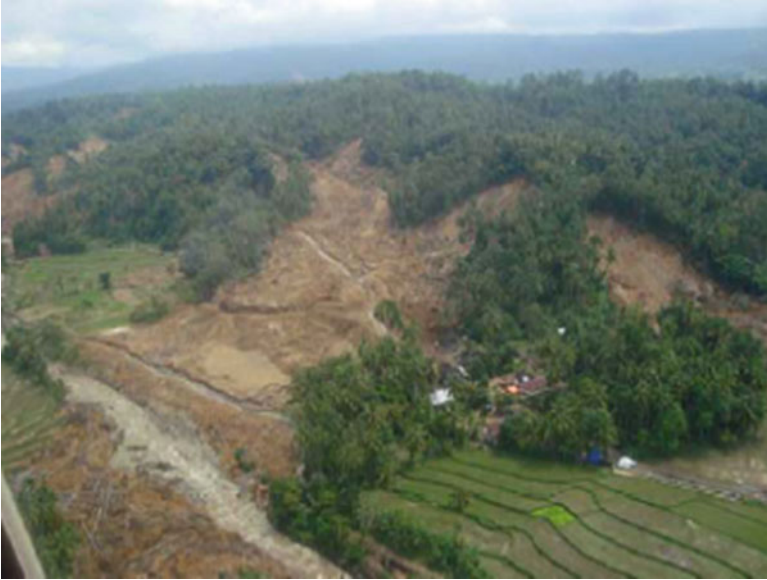
The shaking ground induced landslides and subsequently collapsed slopes at various spots in the mountain areas. As a result, many access roads were cut off, thus creating a significant amount of time to grasp the damage in the affected areas. Extensive landslides in Padang Pariaman resulted in high casualties; three small villages were buried (Fig. 4.5). Observations of the spoil site showed that the pumiceous tuff originating from late eruptions of the Maninjau caldera was light and porous and had little cohesion. Heavy rain over several days before the earthquake probably saturated the ground, increasing the driving force and

Fig. 4.5 Massive landslides occurred in Pariaman: a village below this slide was buried

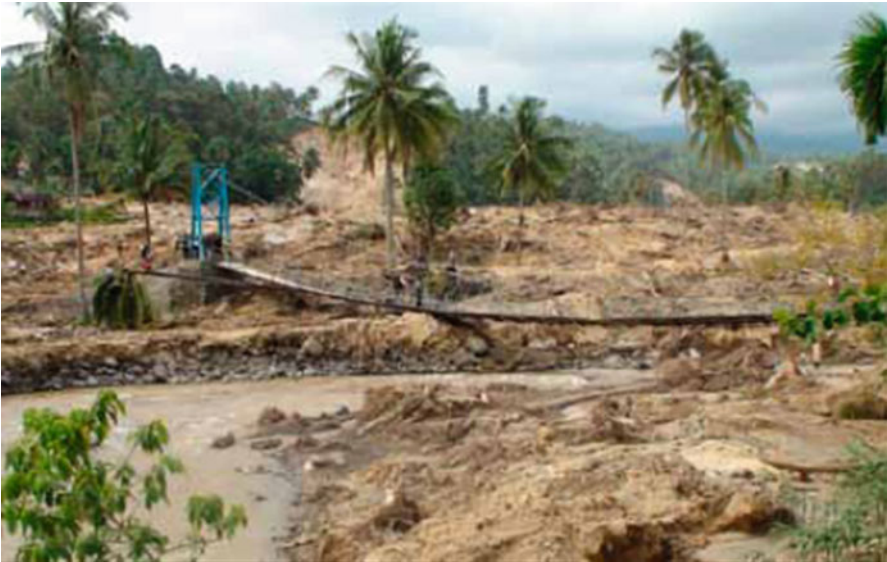
weakening the soil resistance, causing the slope to be marginally stable. The flat lands below the hills at the toe of the hills, consisting mainly of loose silt, sand, and gravel mixtures, may have also lost lateral support and contributed to the massive landslides as well as debris and mud flows (Fig. 4.6). In highland areas, the heavy rain and earthquake caused near-surface loose colluvium to slide (EERI 2009).

Fig. 4.6 Debris flows in rural areas northeast of Pariaman

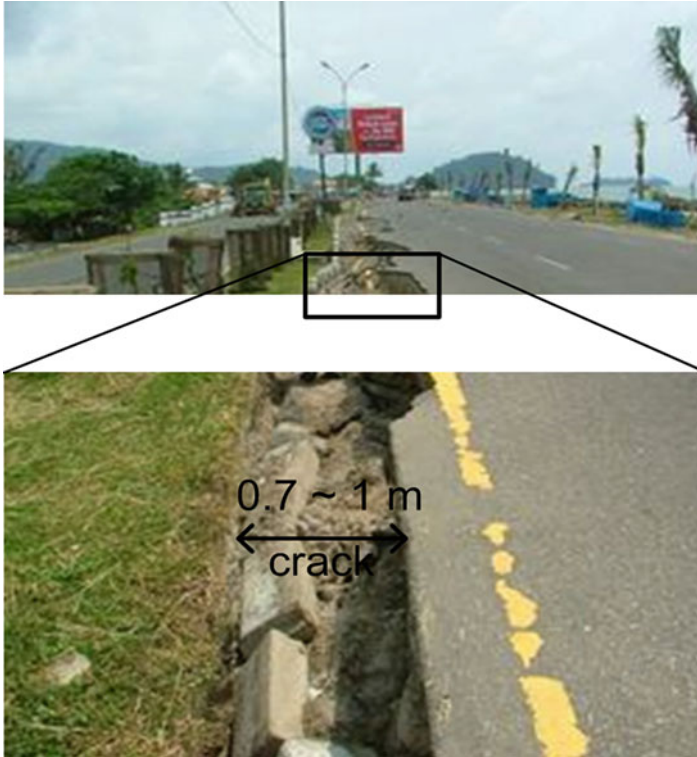
Liquefaction occurred during the quake. Ground amplification of the seismic waves, which was particularly damaging to taller buildings, was reported with a longer natural period. Eyewitnesses described visible ground waves from the earthquake. Most liquefaction and lateral spreading were observed at the area near the coast (Fig. 4.7).

Fig. 4.7 Lateral spreading affecting the Seafront road (Jalan Samaudra) in Padang

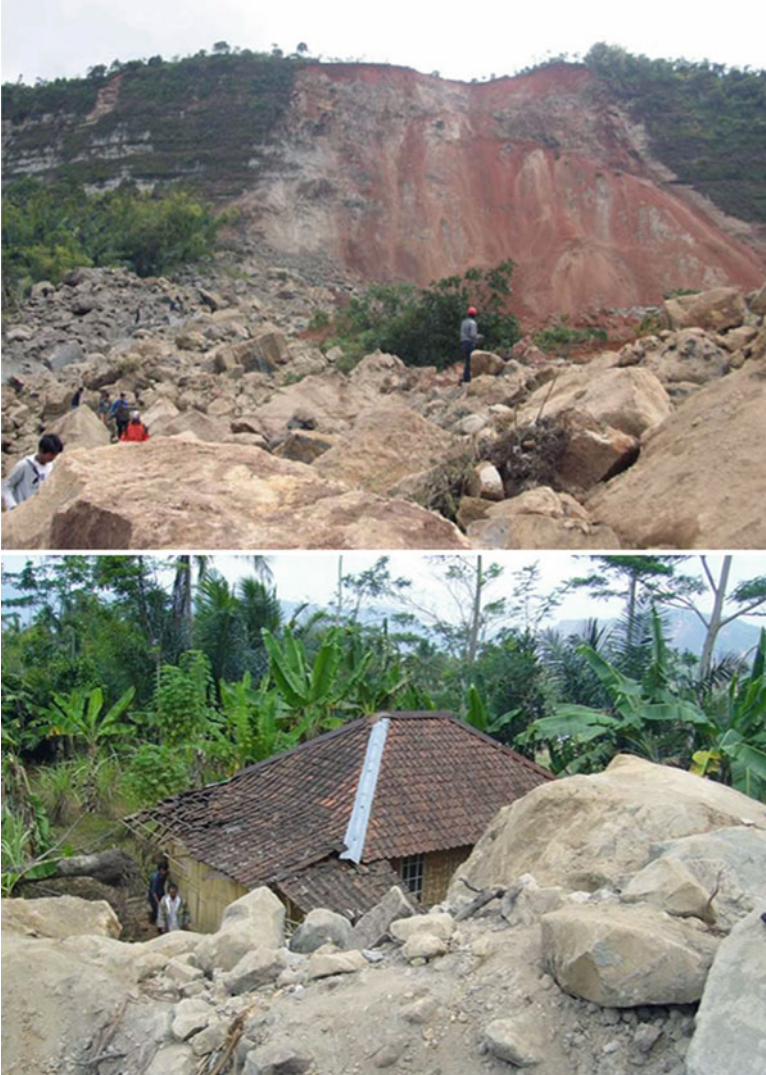
An earthquake induced a huge landslide at Cikangkareng; it buried 12 houses and killed 30 people (Fig. 4.10). The slopes of the region were very steep, about 80–90°, whereas the village was located near the slope. The geologic setting of the region was formed with sedimentary rock that consists of sandstone, tuff, and breccias (Koesmono et al. 1996). During the dry season, the rock weathered and

Fig. 4.10 Landslide induced by earthquake at Cikangkareng, Cianjur: landslide source (*top*); rock debris materials covered village (*below*)

resulted in sandy silt and sandy clay. A joint was formed and a fissure was found near the ground surface. Consequently, the slopes collapsed easily during ground shaking when the earthquake occurred on September 2, 2009. Landslide materials such as rock and earth fall and flow quite fast and ruin villages (Fig. 4.10).

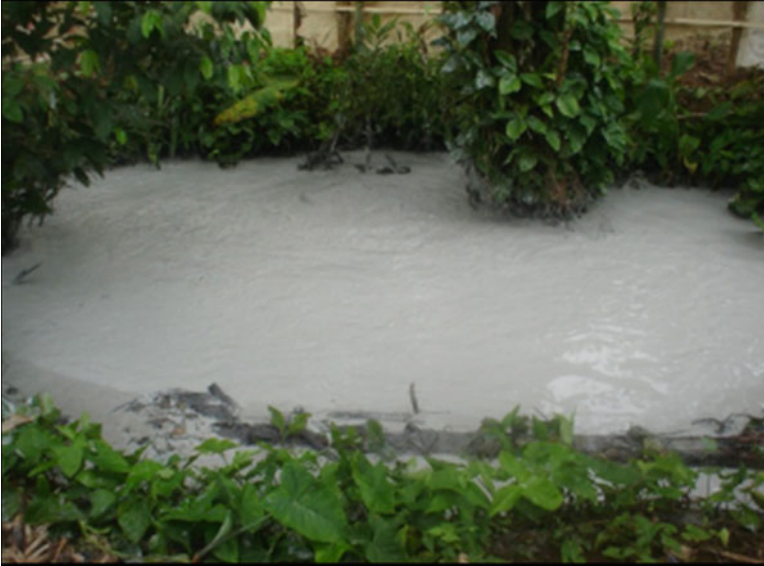
Liquefaction occurred during the earthquake. The ground shaking triggered mudflow at Pasir Gede, Sukahening village (Fig. 4.11). The area is located at $S07^{\circ}12'34,6''$ and $E108^{\circ}08'08,7''$. Based on interviews of local people, similar

Fig. 4.11 Sand boiling at Kp. Pasir gede, Sukahening village, Sukahening, Tasikmalaya

mud flows occurred in 1952 and 1982. According to the geology map (Budhitrina 1986), the mud flow location was laid on volcano sediment, breccia, lahar, and tuff underlain with andesite and basalt from the Talagabodas volcano. There was no fault observed in the mud flow region. However, the quake was possibly caused by a shear joint adjacent the aquifer layers. As a result, the gray color of mud flowed out with water because of pressure from the aquifer.

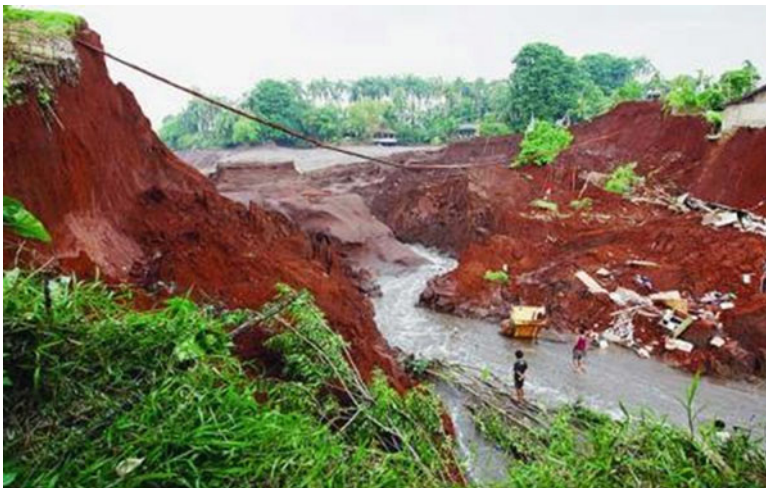
On Friday morning, March 27, 2009, at 2:00 a.m., the Situ Gintung dam burst in Cirendeu, Ciputat, Tangerang, Banten Province (Fig. 4.12). The dam failure was triggered by torrential rains. The water in the reservoir, about 15-m wave of water, flushed into houses and villages downstream (Fig. 4.12). The dam was originally built by Dutch colonial authorities in 1933. It was made from earth compacted into a wall 16 m high, and the reservoir held at least two million cubic meters of water. The original imperative of the dam had been to retain water for irrigation of rice paddies, which were subsequently replaced by urban development.

Heavy rain was indicated as the triggering factor for the dam failure. On March 26, 2009 at 4.00–7.00 p.m., the nearest rainfall station in Ciputat (Balai II) recorded a rainfall duration of about 4 h, with accumulated rainfall of about 113 mm (BMKG 2009). The rainwater caused the water level in the reservoir suddenly rise. However, overflow of the water could not spill out through outlet tunnel because the spillway and outlet malfunctioned. Consequently, the water overtopped the crest of the earth dam. The overtopping caused some piping and cracks at the toe downstream of the dam. The piping allowed water to infiltrate the capillary breaks that caused the dam to collapse. Piping was also identified by eyewitnesses in December 2008.

Fig. 4.12 Collapse of the Situ Gintung dam on March 27, 2009

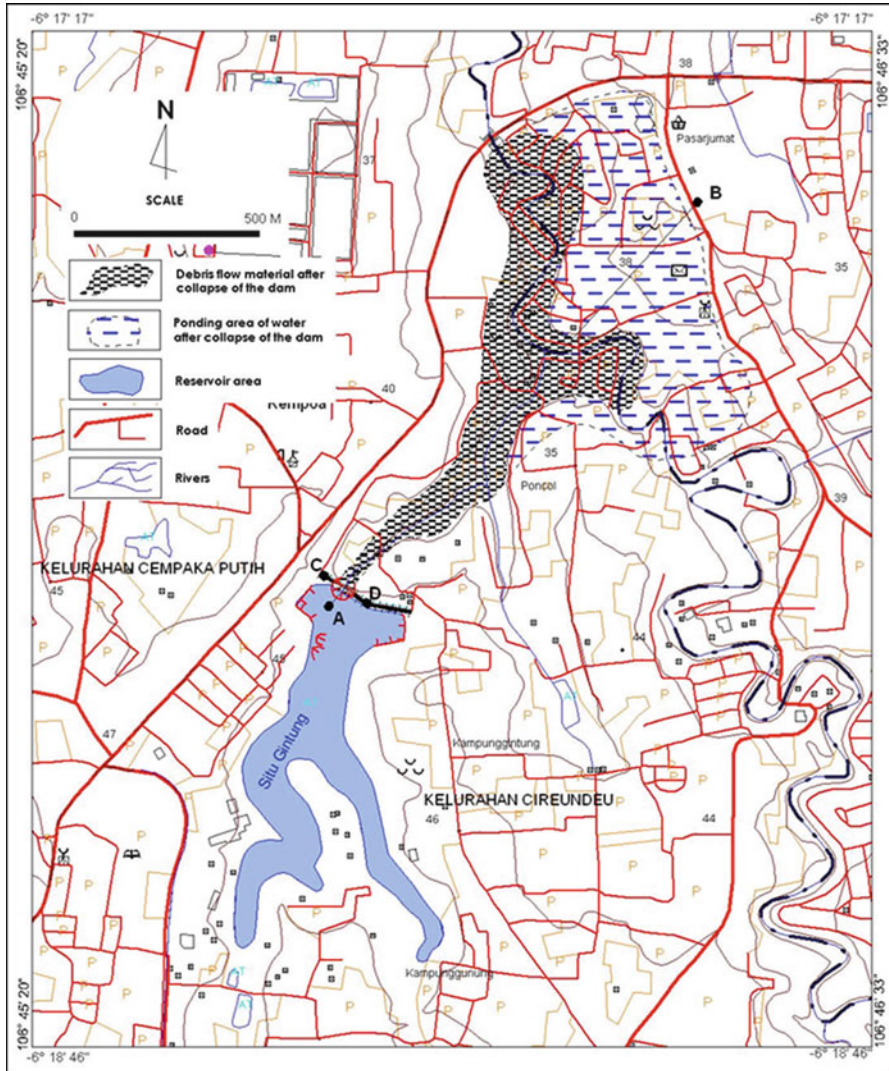
Fig. 4.13 Catchment area of Situ Gintang and the location of debris materials after the collapse of the dam

To reduce disaster risk, mitigation has to be implemented continuously. Many dams in Jakarta and other regions are also located in heavily populated areas. An early warning system (EWS) has to be built to reduce the risk. An EWS includes routine maintenance of the dam, improving land use, and spatial planning, empowerment, and participation of the local society (Fig. 4.13).
