Chapter 4

Lessons Learned from the Recent Natural Disasters in Indonesia

Sri Prabandiyani Retno Wardani and Agus Setyo Muntohar

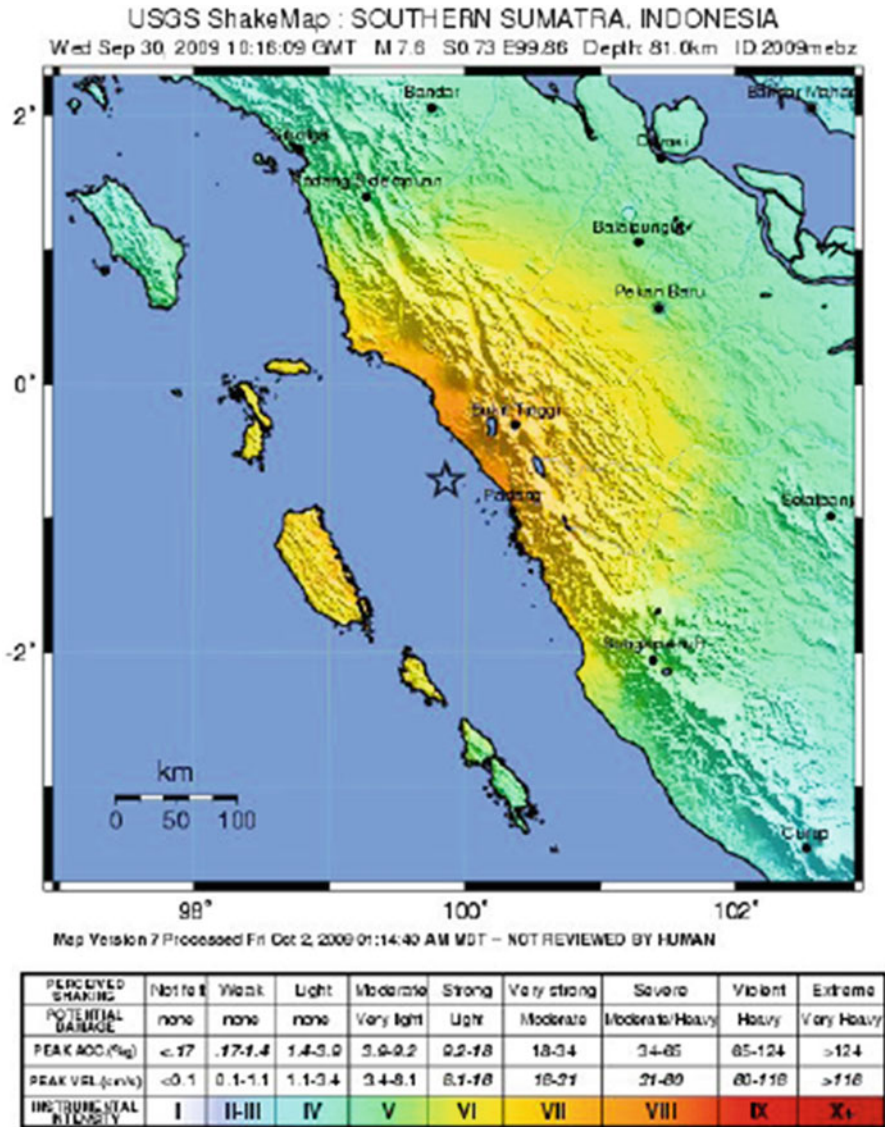
Fig. 4.4 Earthquake intensity map on September 30, 2009 (USGS)

A 7.6-Mw earthquake hit Padang on September 30, 2009. The epicenter was about 60 km northwest of Padang, at a depth of more than 120 km. The Mentawai Fault was responsible for this earthquake. This fault is parallel to the Sumatra Fault and situated between the trench and the Sumatera fault (Fig. 4.2) (Shieh 2009). Many aftershocks occurred, and more were expected in the days and months ahead. Most aftershocks are at least two degrees of magnitude smaller than the main shock, such as the first reported aftershock, which was 5.5 Mw. The 6.6-Mw earthquake on October 1 appears to not have been an aftershock strictly speaking. It occurred more than 200 km away from the September 30 earthquake rupture on a section of the Sumatran fault. That fault produced many large (7–7.5 Mw) earthquakes between 1892 and 1953, but had been mostly quiet for the past half-century. Figure 4.3 shows the relationship of the September 30, 2009 earthquake to the September 2007 ruptures (Konca et al. 2008). The earthquakes in September 2009 years ago were caused by fault ruptures farther to the south from Padang. The seismic intensity distribution of the earthquake was shown in Fig. 4.4 (BMKG, USGS 2009, USGS). In Padang and Pariaman, the reported earthquakes were greater than VII on the Mercalli scale. At those locations, there was heavy damage to both infrastructures and lives.

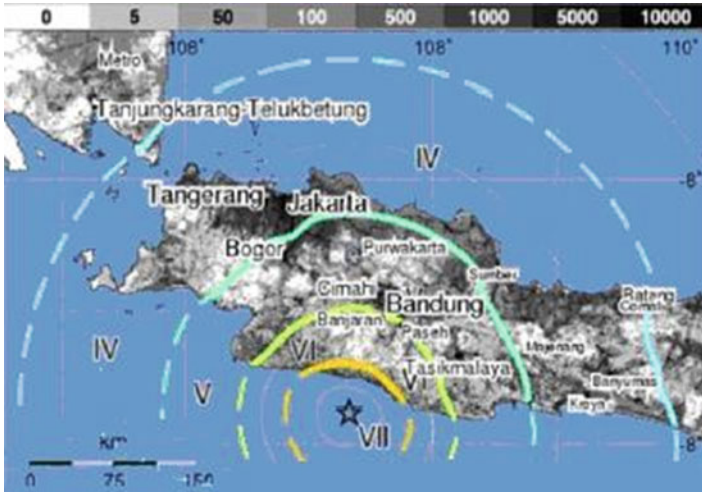
Fig. 4.8 Earthquake intensity distribution on September 2, 2009 quake off the south coast of West Java (USGS)

On September 2, 2009, a 7.3-Mw earthquake struck the Tasikmalaya District, West Java Province, at a depth of 30 km. A second 5.1-Mw earthquake followed at 3:15 p.m. at a depth of 38 km. A third 5.4-Mw earthquake struck at 4:28 p.m. at a depth of 15 km. A tsunami warning was issued but was withdrawn 1 h later. Affected districts and municipalities included Bogor, Cianjur, Sukabumi, the municipality of Sukabumi, West Bandung, Bandung, Garut, Banjar, Ciamis, the municipality of Tasikmalaya, and Purwakarta. The shaking was felt widely on Java, with maximum MMI intensities of VII at Tasikmalaya, VI at Cianjur and Sukabumi, V at Bandung, and IV at Jakarta. Figure 4.8 shows the earthquake intensity distribution and the damage level of the affected area; a historical earthquake in West Java is shown in Fig. 4.9 (USGS).
